Case Study

## Shetland Isles Leisure Centre

Scope of works:

Full AHU upgrade

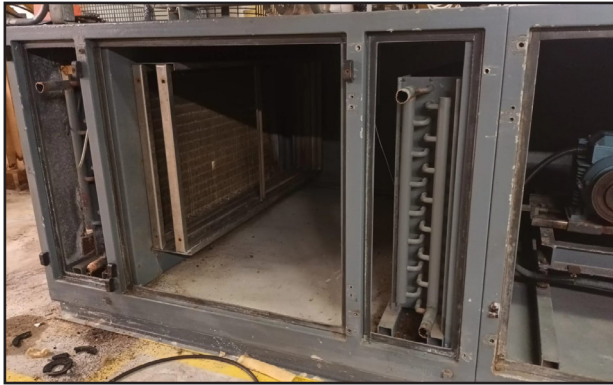
### Before Upgrade - AHU4

**The original units had been affected by corrosion and internal parts were at the end of their life cycle.**
