Case Study

## Hospital

Toilet extract twin fan

Replaced failed fans with direct drive EC fans,  
new auto changeover panel, new roof

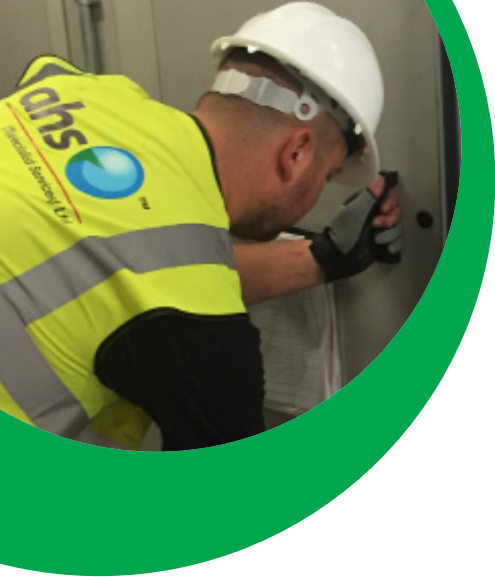
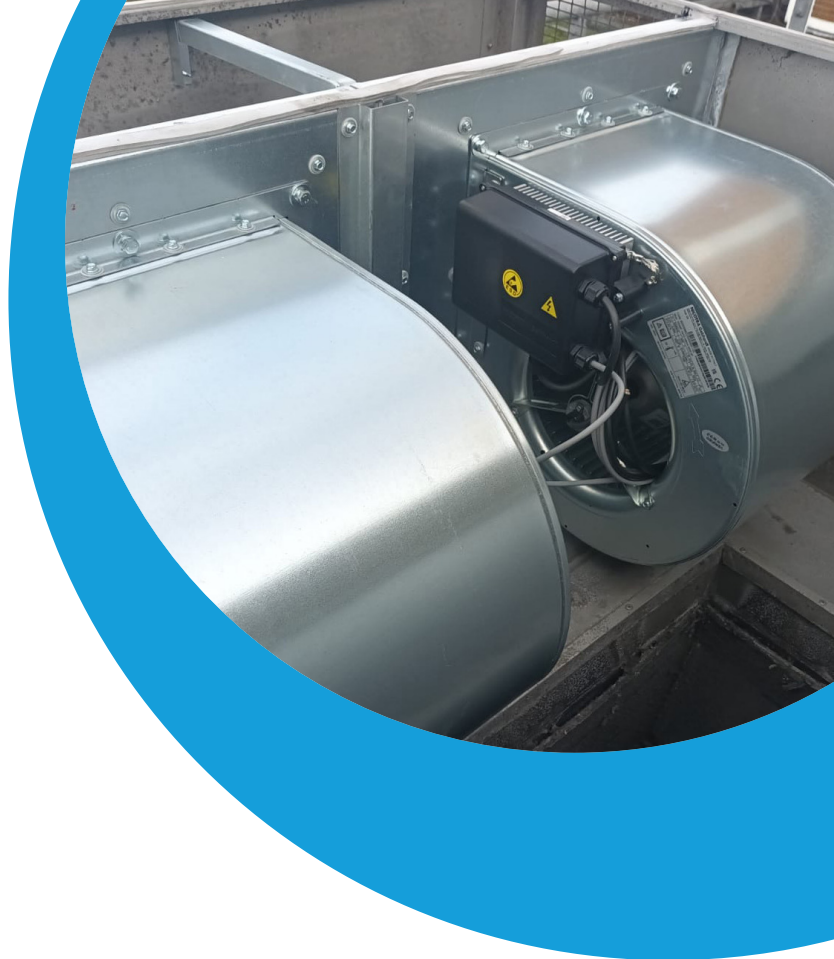
**The original units' fans had failed, along with the roof becoming damaged and being held in place by a paving slab.**

Due to budgetary constraints, the customer could not afford the cost of a full replacement and on inspection of the original casework, a solution to upgrade the fans and installing a replacement roof was proposed to fit the customer's budget.
